**Subject: Annual Inspection Report  
Camden Municipal Airport**

## ANNUAL INSPECTION REPORT

CAMDEN MUNICIPAL AIRPORT

# Annual Inspection Report Camden Municipal Airport Camden, Alabama

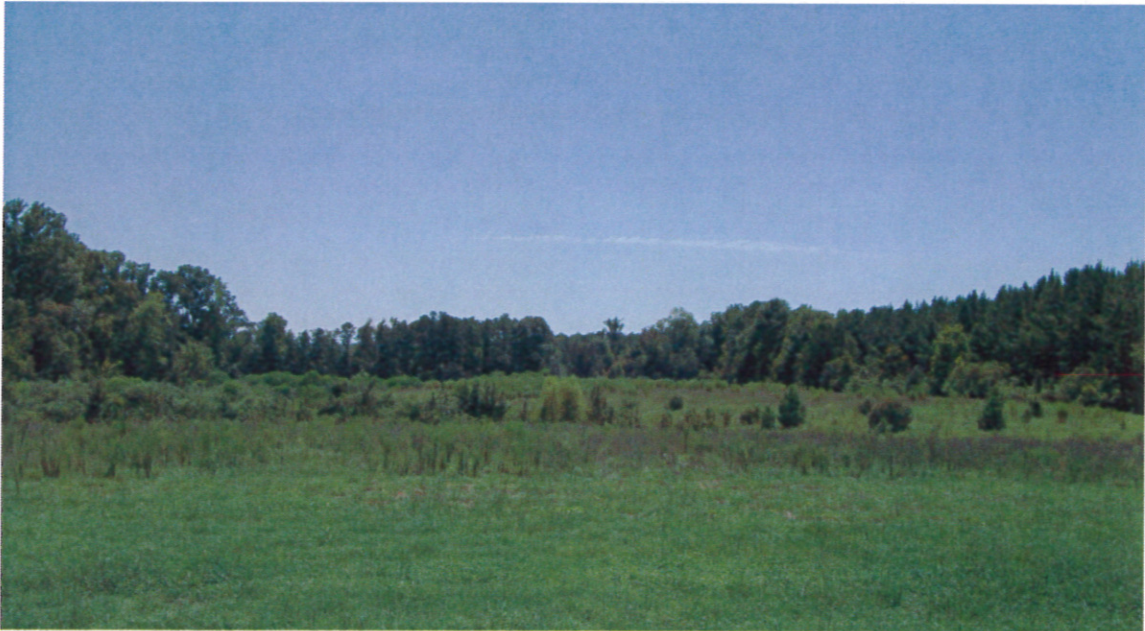
**Photo # 1 – Rwy 36 Approach**

- Runway 36: No obstructions (See Photo # 1 and Appendix 2).
- Runway 18: Brush identified as Brush # 9 violates the 20:1 approach/departure path (See Photo # 2 and Appendix 3).

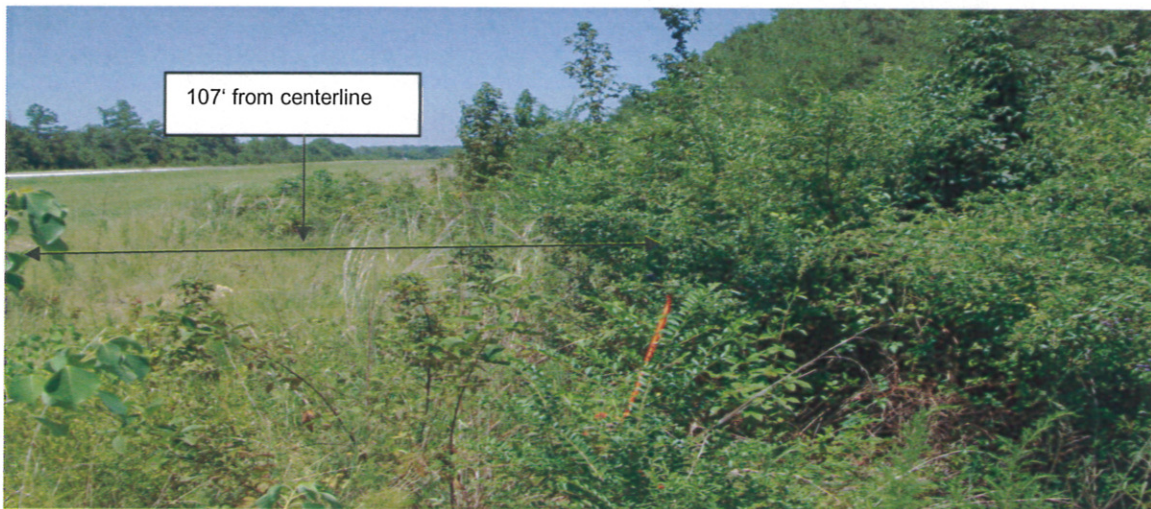
**Photo # 3 - Primary Surface**

- The primary surface has brush growing within 125 feet from the centerline of the runway. Brush was found on the east side of the runway, south of the parking apron (See Photo # 3) and on the west side of the approach end of runway 18 (See Photo #4) .

- All natural obstructions must be removed and primary surface should be kept in a mowable condition.

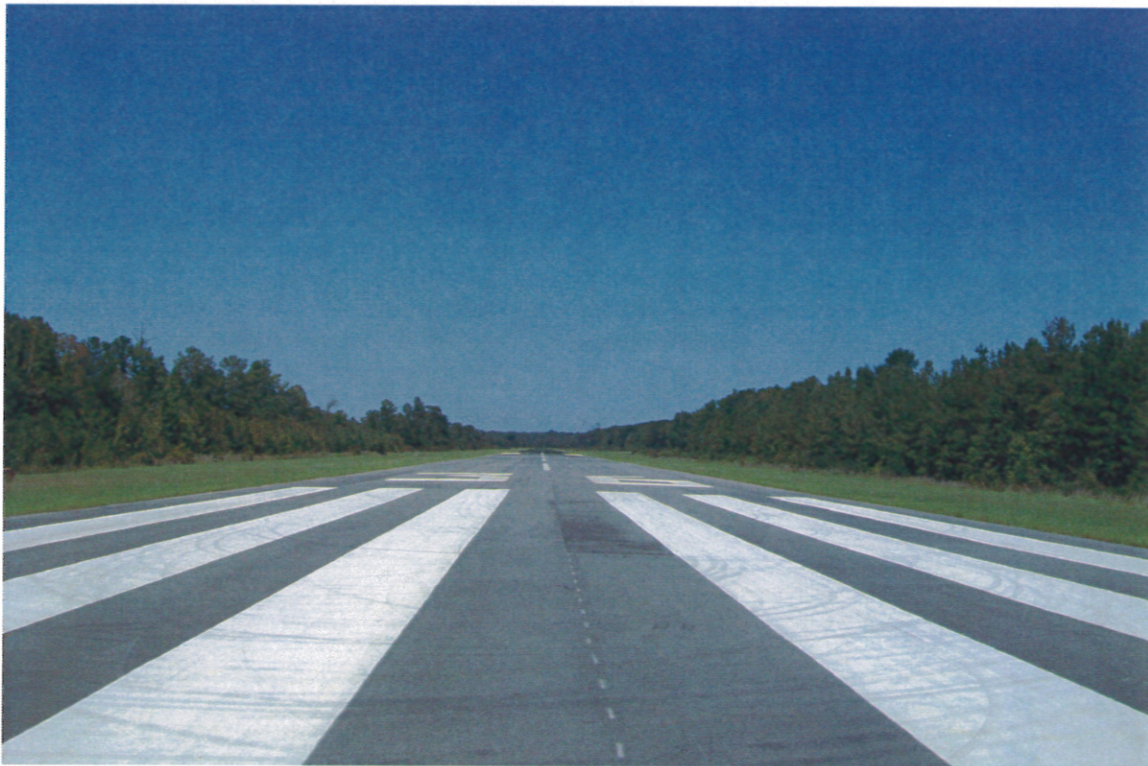
**Photo # 5 – Runway Markings**

- The runway markings are in good condition (See Photo # 5).

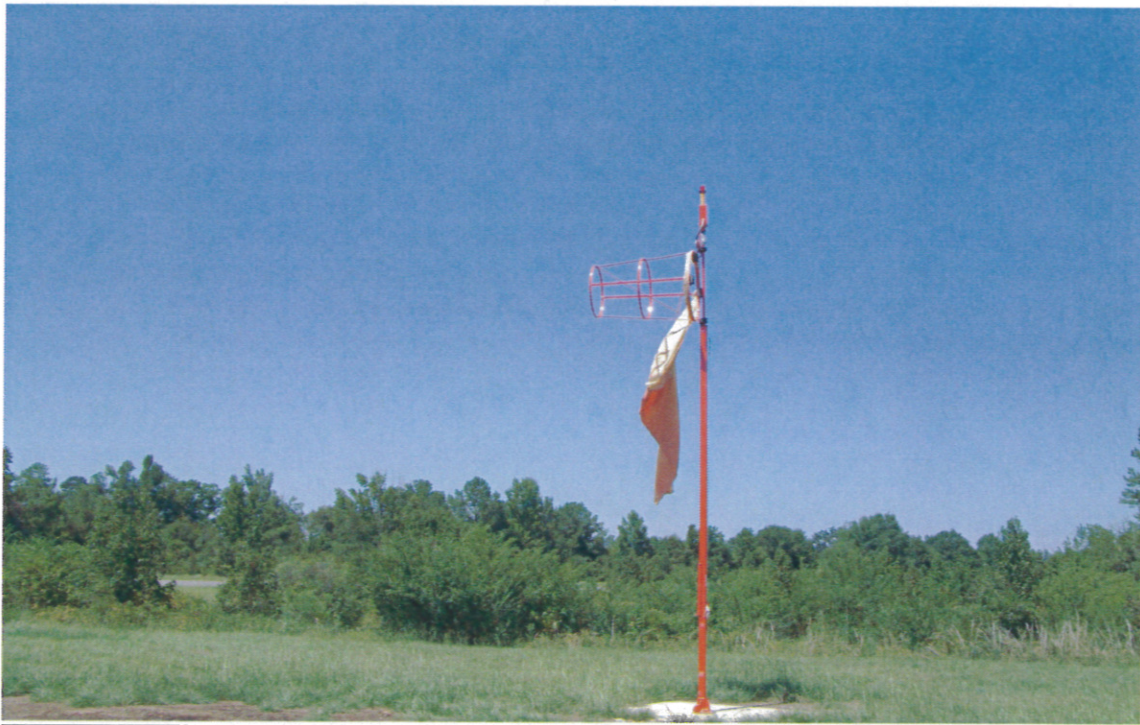
**Photo # 6 Wind Cone**

- The wind direction indicator (wind cone) is inoperable due to condition of the wind cone fabric (See Photo # 6).

- Wind cone fabric must be replaced.

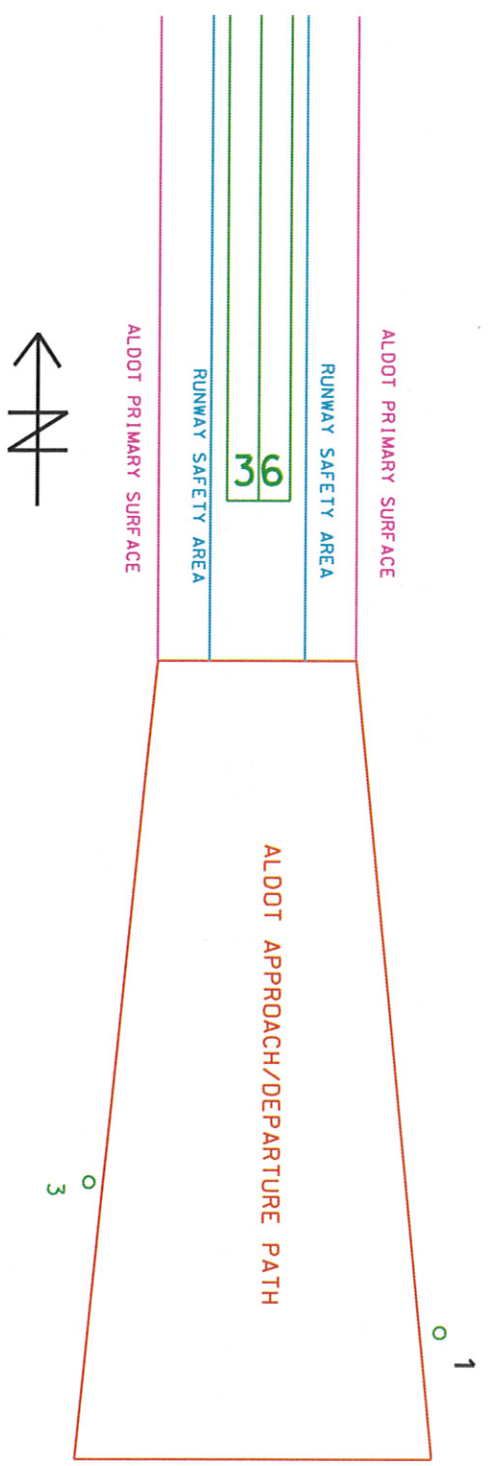
## REQUIREMENTS FOR STATE AIRPORT LICENCE RUNWAY 36

THE ALDOT APPROACH/DEPARTURE PATH IS FREE OF OBSTRUCTIONS

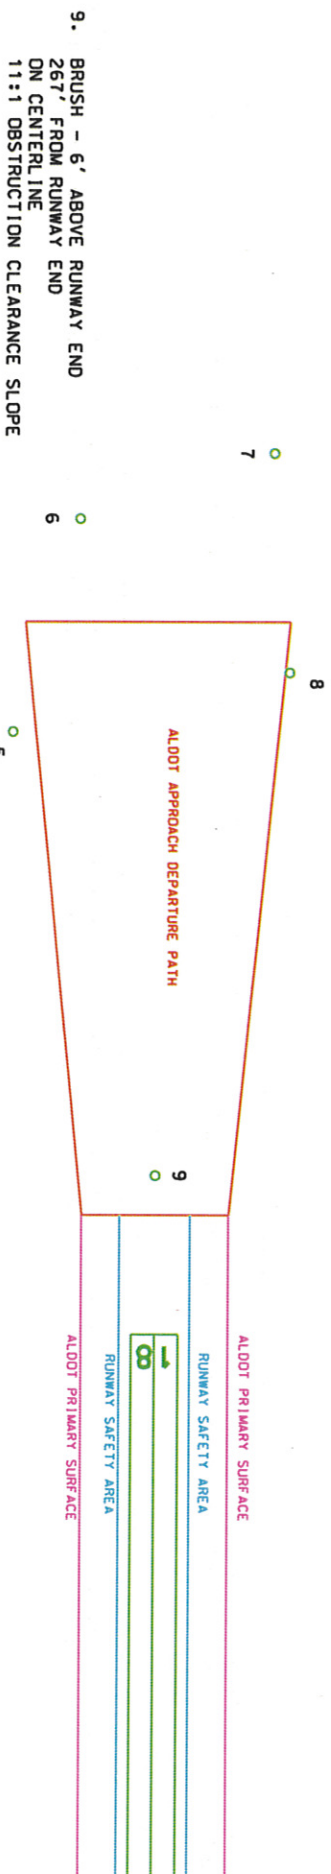
## REQUIREMENTS FOR STATE AIRPORT LICENCE RUNWAY 18

9. BRUSH - 6' ABOVE RUNWAY END  
267' FROM RUNWAY END  
ON CENTERLINE  
11:1 OBSTRUCTION CLEARANCE SLOPE

- All the brush growing along the fence should be removed, only the brush closest to the centerline was measured as being an obstruction.
